17th May 2016

An ecological fish survey of Reservoir creek to determine fish passage barriers, and recommendations for improved fish passage in these problem areas.

Overview

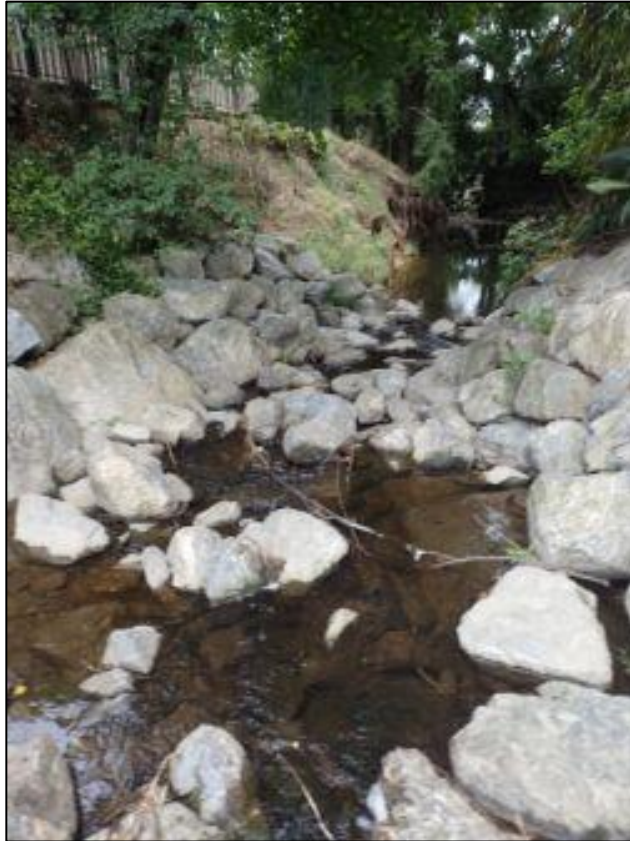
Directly above Salisbury Bridge (*fig 1*) a series of large rocks lining the creek bed create a mixture of pools and riffles. Further upstream deeper pools develop with a fine sediment bed. A mixture of riparian planting creates cover for fish species and canopy cover shades large sections of the creek, and at times the grass verge from the footpath travels right to the creeks edge.

Figure 1. Large rocks upstream Salisbury Bridge

Large rocks lining the stream bed just above Salisbury Bridge (*fig 1*) need to be monitored as there is a risk of debris building up causing a blockage under the bridge. Currently it is clear. The irrigation pond (*fig 2*) referenced as the upper boundary of this reach is believed to be put in by a nearby resident. Concrete has been placed in the stream to dam the water. Although it is a fairly minor structure and does not act as a barrier for fish movement it is recommended that it is pulled out. This is because it may lock up debris and as a result create fish passage issues.

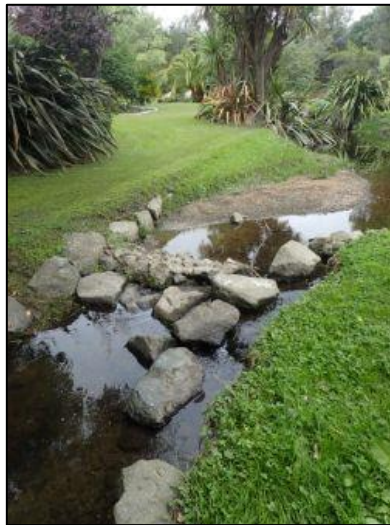
Figure 2. Residential irrigation pond

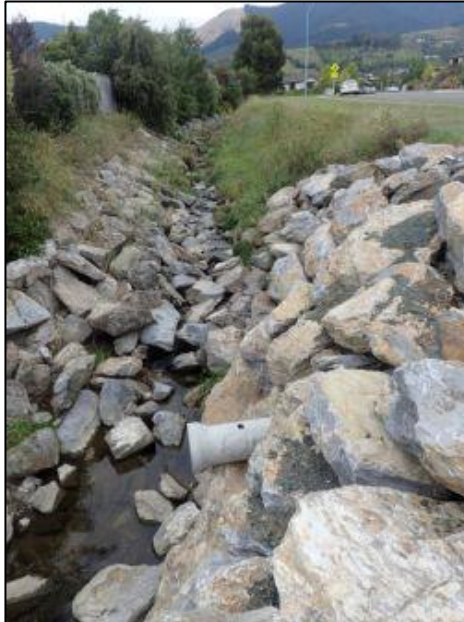
The habitat above the Kareti Drive Bridge differs from the downstream reaches in that large rocks line the channel and banks (*fig 3*). As a result, voids have been created with a low percentage of gravels and cobbles present within them. A large portion of this reach consists of slow moving water as a result of its passage through and beneath the large rocks. No obvious pools can be seen. Some well-established grasses cover the bank edges but the creek is void of any significant riparian planting and canopy cover.

Figure 3. Upstream Kareti Drive Bridge

Before Fish and Wildlife Services had surveyed Reservoir Creek, an area directly above the Kareti Drive Bridge was pointed out as being a potential problem for fish passage by Trevor James (resource scientist at Tasman District Council). The problem lies with the large rocks armouring the creek bed, where at times the channel was not obvious and flowed beneath these rocks. A realignment of some rocks to create a more structured channel and fish passage was carried out by Mr James.

The fish data results indicate that fish passage through this reach is sufficient with longfin eels, common bullies and eels (less than 200mm) all either abundant (*table 1*) or very abundant right up to Templemore Bridge. A large number of the eels observed were between 50- 60mm which suggests they are migrating upstream. The low numbers of inanga, in comparison with surrounding reaches, is believed to be attributed to habitat factors, such as a lack of pool habitat and overhead planting, and not due to fish passage barriers. Whilst it appears fish passage is sufficient in reach 3, there is an opportunity to further improve fish passage by manoeuvring the larger problem rocks in the bed to create a meandering low flow channel. Fish habitat can also be enhanced by creating more pools in the stream and establishing some riparian planting for stream shading.

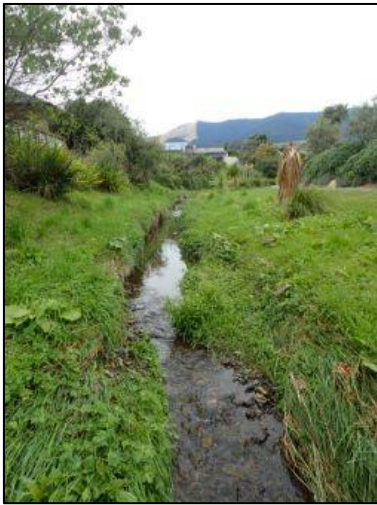
This reach shows a stark contrast between different fish habitats. The lower section of this reach is quite uniform and is almost one continuous pool. The grass bank, which has no riparian planting, creates a straight lined channel filled with moderately sized cobbles (*fig 7*). The upper section is very similar with the only difference is there are a few more trees present (*fig 9*). The middle section however has had some obvious development shown by large rocks surrounding the bed forming a stable bank. Rocks within the bed have created a sequence of riffles and pools and the entire area has been planted out providing excellent shading and cover (*fig 8*).

Figure 7. Reach 5 lower section

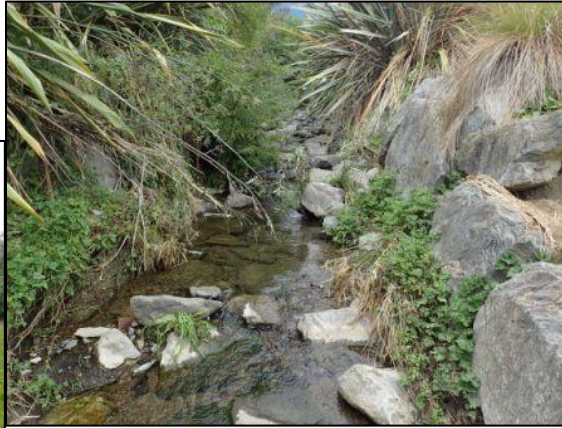
Figure 8. Reach 5 middle section

The middle section of reach 5 (*fig 8*) showed higher numbers of inanga and bullies compared to the lower and upper sections. This is another example of an urban stream redevelopment providing good habitat for the more tolerant fish species. With this information in mind it is recommended some riparian and canopy planting takes place in the lower and upper section of reach 5 to provide more fish cover and stream shading. There might be an opportunity to get local schools involved with the planting.

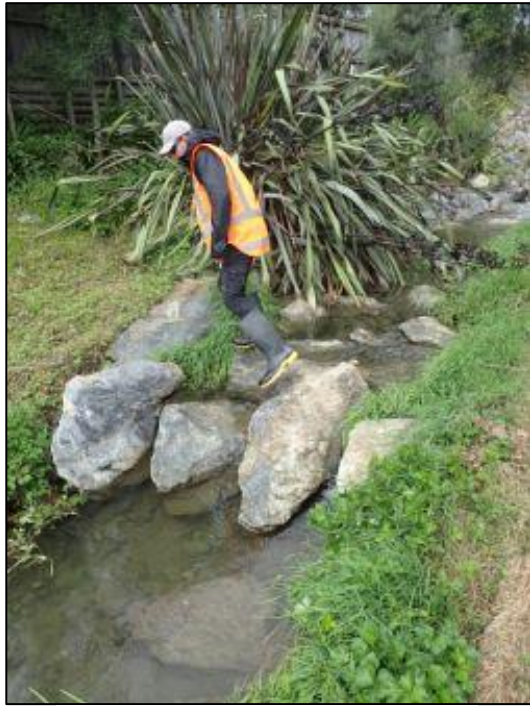
Twenty meters below the Hill Street culvert at the head of a pool, three large rocks form a raised shelf (*fig 10*) which under low flow conditions could create a difficult passage for fish upstream. Currently it does not appear to be an issue for fish passage, however during the summer months when flows become low it will need to be assessed again. An option may be to install some mussel ropes to aid fish passage. A large pool at the base of these rocks contained several inanga therefore their placement is improving fish habitat.

Figure 10. Large rocks downstream Hill street culvert

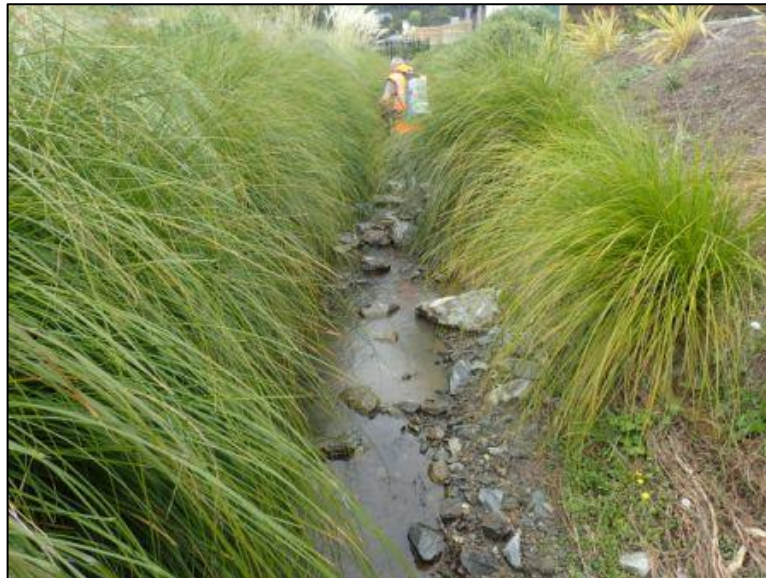
This stretch of creek is narrow with shallow, fast water and a low number of pools (*fig 11*). Gravels and cobbles provide fish habitat with larger rocks creating some cover and a slight meander effect. Reach 6 shows a high percentage of fine sediment cover; at times reaching 80%. The sediment has likely flushed downstream from the Reservoir dam in the upper catchment. Some riparian planting is present overhanging the creek. Watercress is dominant at times near the household entrance culverts.

Figure 11. Upstream Hill street culvert

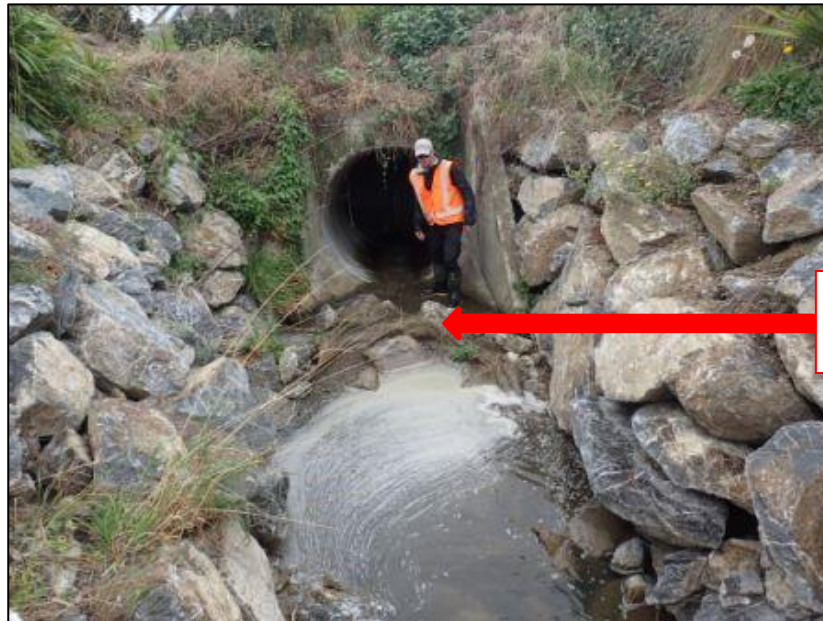
Filter cloth

The Hill Street culvert (*fig 16*) between reach 5 and 6 appears to be acting as a true fish passage barrier. Furthermore, immediately above the Hill Street culvert two potential fish passage barrier are apparent. The first (*fig 12*) is a build-up of rocks behind a piece of uplifted filter cloth which had been placed during the redevelopment of this reach. It is unknown how long this barrier has been in place; therefore it is recommended a survey is undertaken next year to establish just how intrusive it has been on fish passage. The cloth was partially cleared by Fish and Wildlife Services, but a complete removal is recommended (*fig 13*).

Figure 12. Uplifted filter cloth backing up water

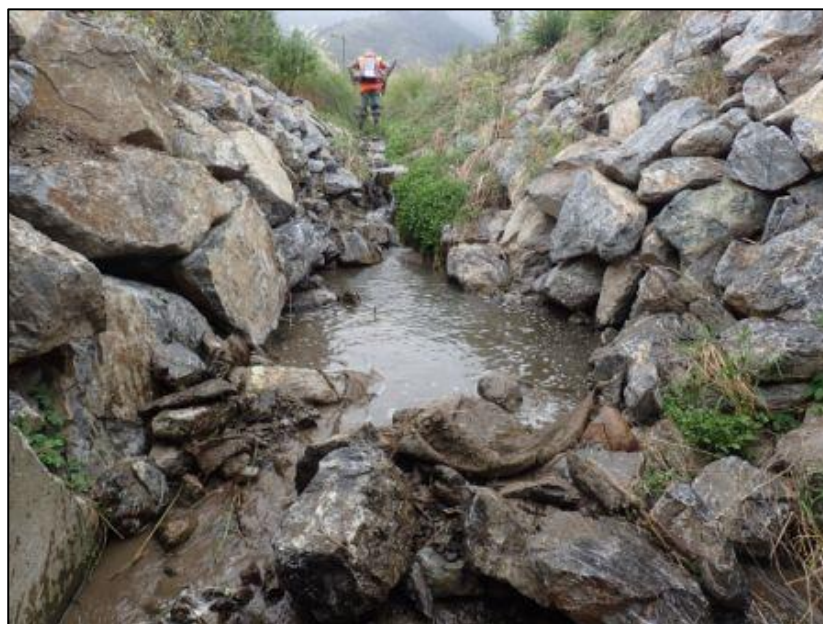
Figure 13. Uplifted filter cloth partially cleared

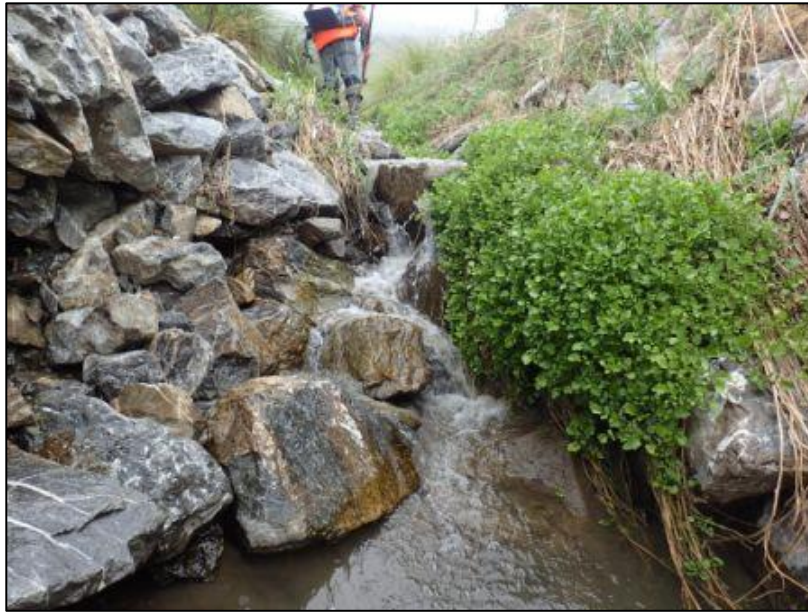
The second barrier (*fig 14*) is minor and a result of a drop in gradient within the stream caused by rock armouring from the bank to the bed. Adult fish would not have a problem passing this area; however juvenile fish might find it a partial barrier. Use of mussel ropes or a rock ramp might allow easier access upstream.

Figure 14. Rock armouring causing a gradient drop in the stream

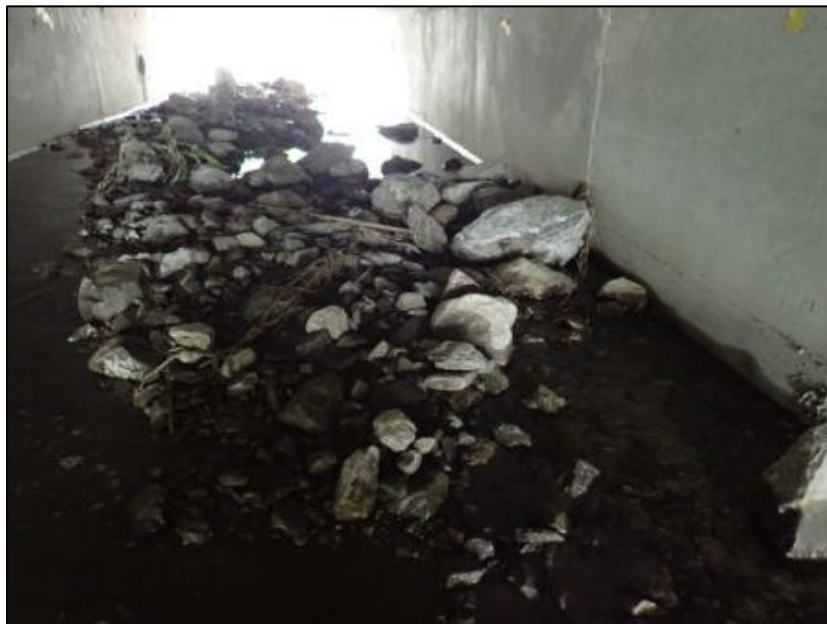
Further upstream on Concordia Lane there are four culverts created for vehicle access to households. At least two of these culverts have a build-up of rocks and gravels which under low flows could impede fish passage (*fig 15*). This is due to the water percolating through the gravels and not as a surface flow. The gravels do however create a good habitat for fish when there is flow. Therefore no action needs to be taken in these culverts.

Figure 15. Rocks and gravel build up in Concordia Lane culvert

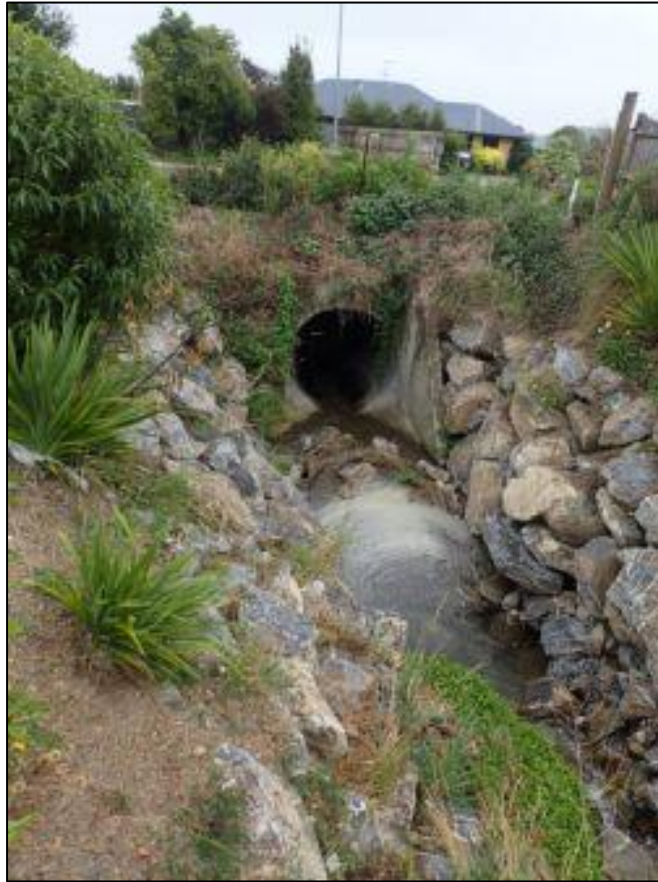
Figure 16. Hill Street culvert

The barriers within reach 6 already described are minor, with only the build-up in front of the filter cloth a partial fish passage barrier. Whilst this filter cloth could be an explanation for the lack of native fish species past this point, because of its likely recent occurrence, it is not thought to have played a major role in preventing fish access. Instead the most restrictive barrier is believed to be the Culvert which lies beneath Hill Street (*fig 16*). It is a major culvert with a steep velocity gradient which inanga, smelt and bullies appear unable to swim through. Some eels appear unaffected by the culvert as evidence by both juvenile and adult eels observed in reach 6. However, in comparison to downstream reaches, both longfin and shortfin eel numbers are low therefore it is unknown how much eel passage through the Hill Street culvert is affected. The top end of the culvert (*fig 16*) was assessed by Fish and Wildlife Services and considered a velocity barrier to fish passage. Therefore it is recommended that baffles are installed inside the top of the culvert to minimize water velocity. Another recommendation would be to have the entire culvert inspected for fish passage barriers.
